PERATION

GREENHOUSE

SCIENTIFIC DIRECTOR'S REPORT

ANNEX 3.2 U. S. NAVY STRUCTURES

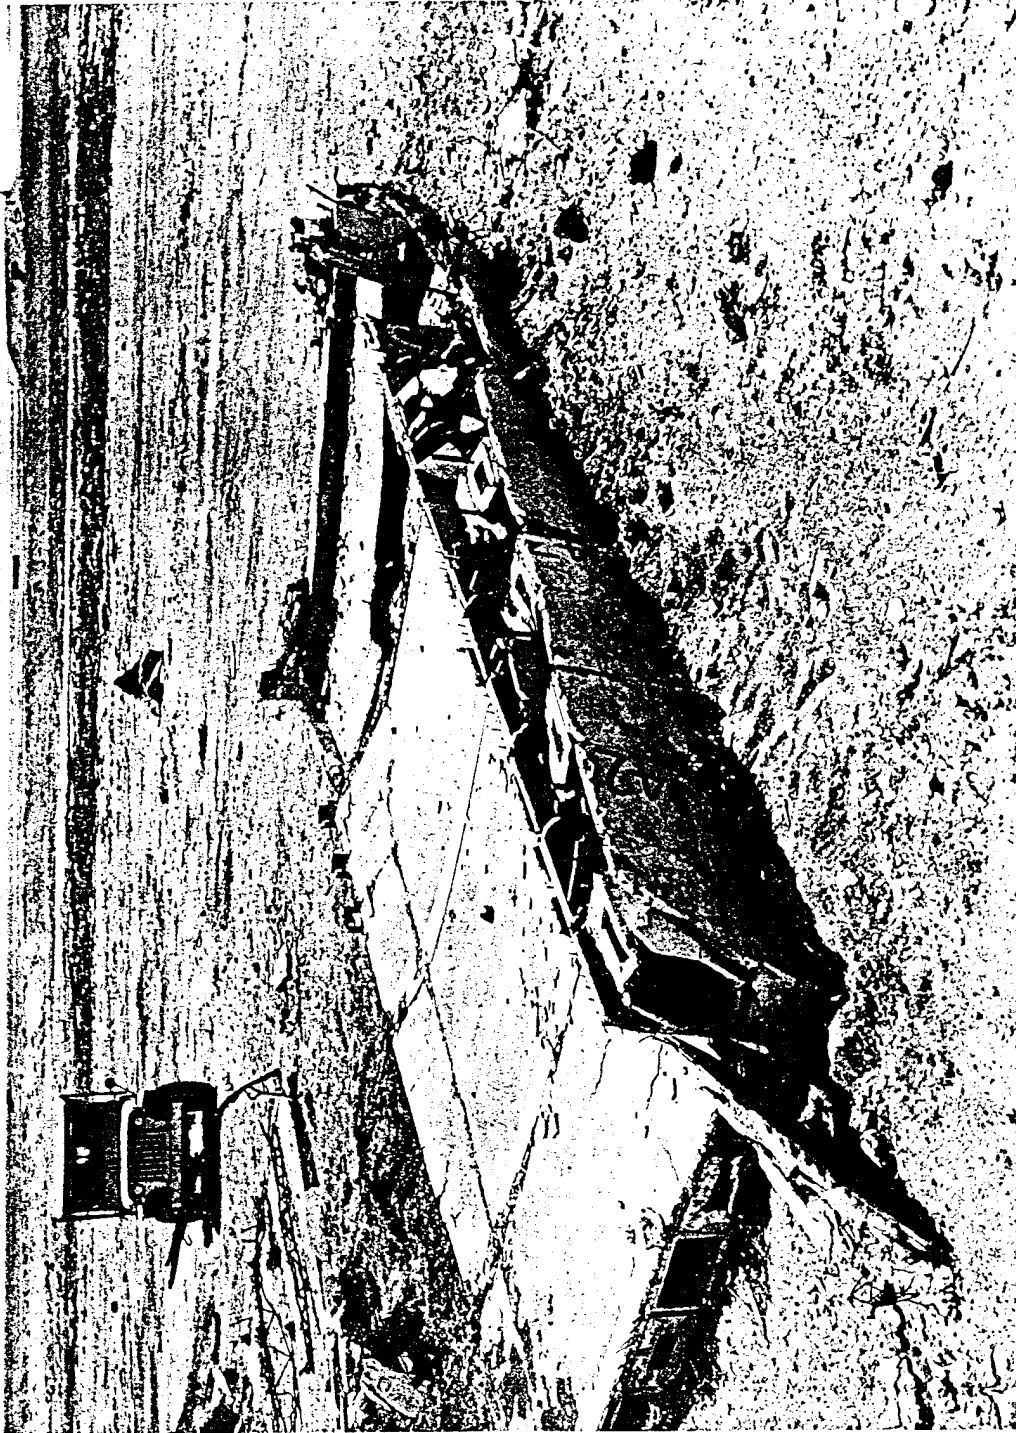
Fig. L.172 General View of Upper End of Left Wall, Structure 3.2.3a. Note distortion of cells where roof was severed from end wall.

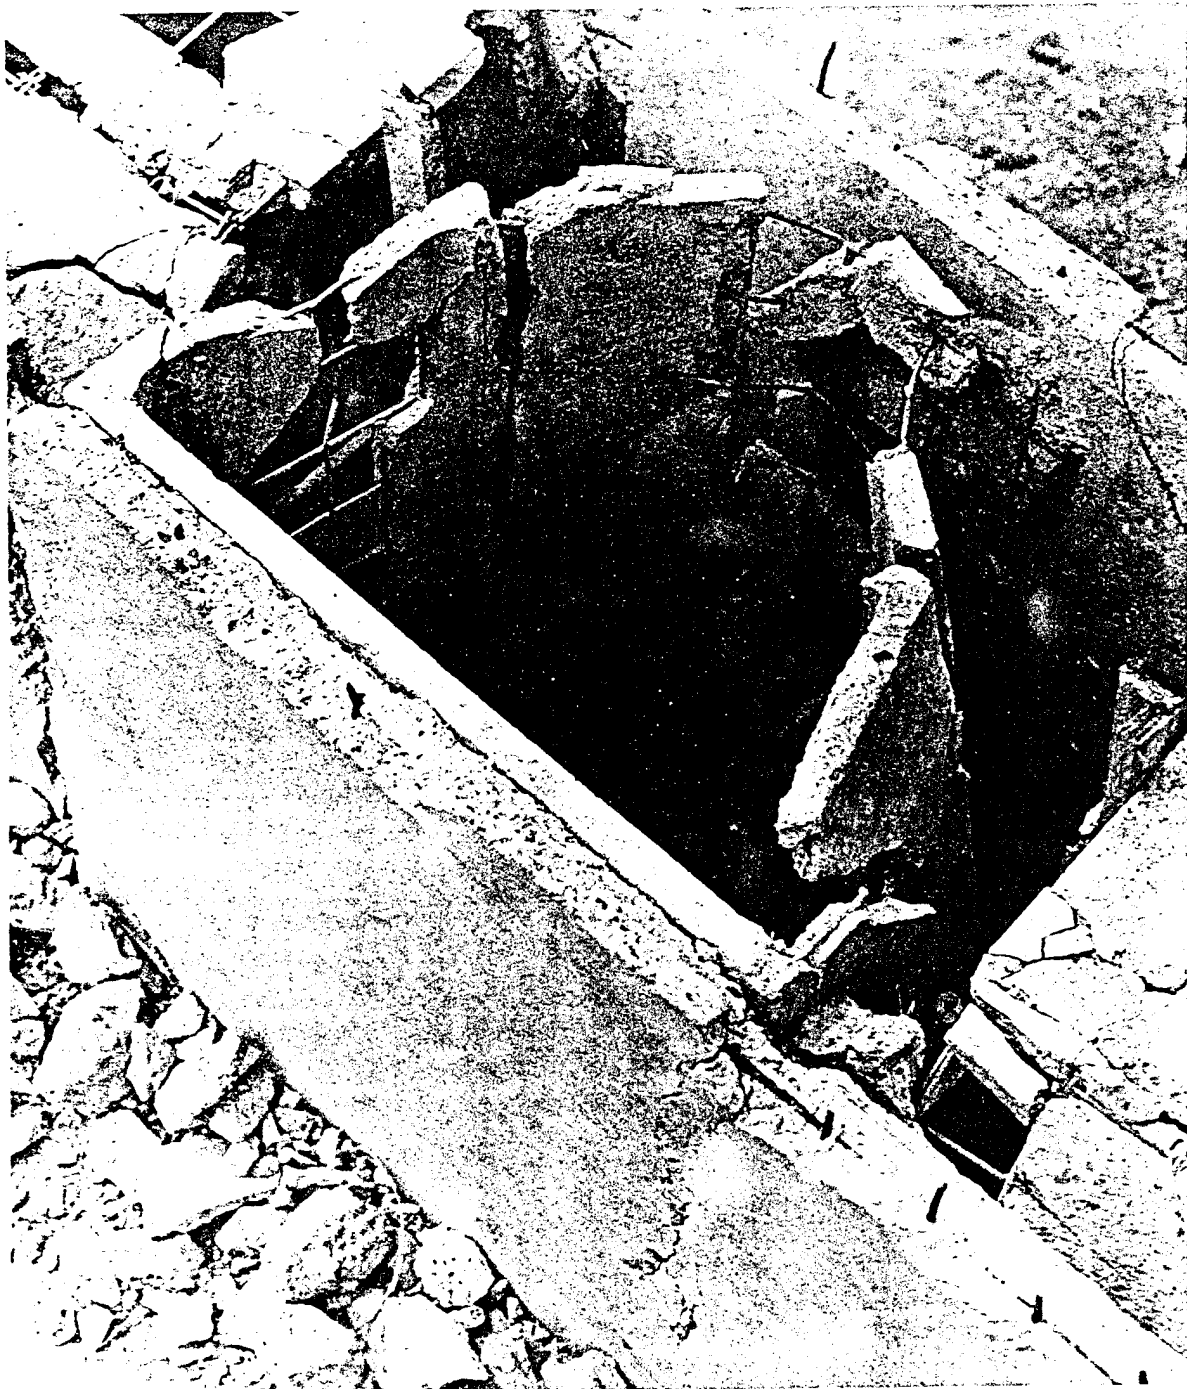
Fig. L.173 Detail View of One Cell from Preceding Photograph, Structure 3.2.3a

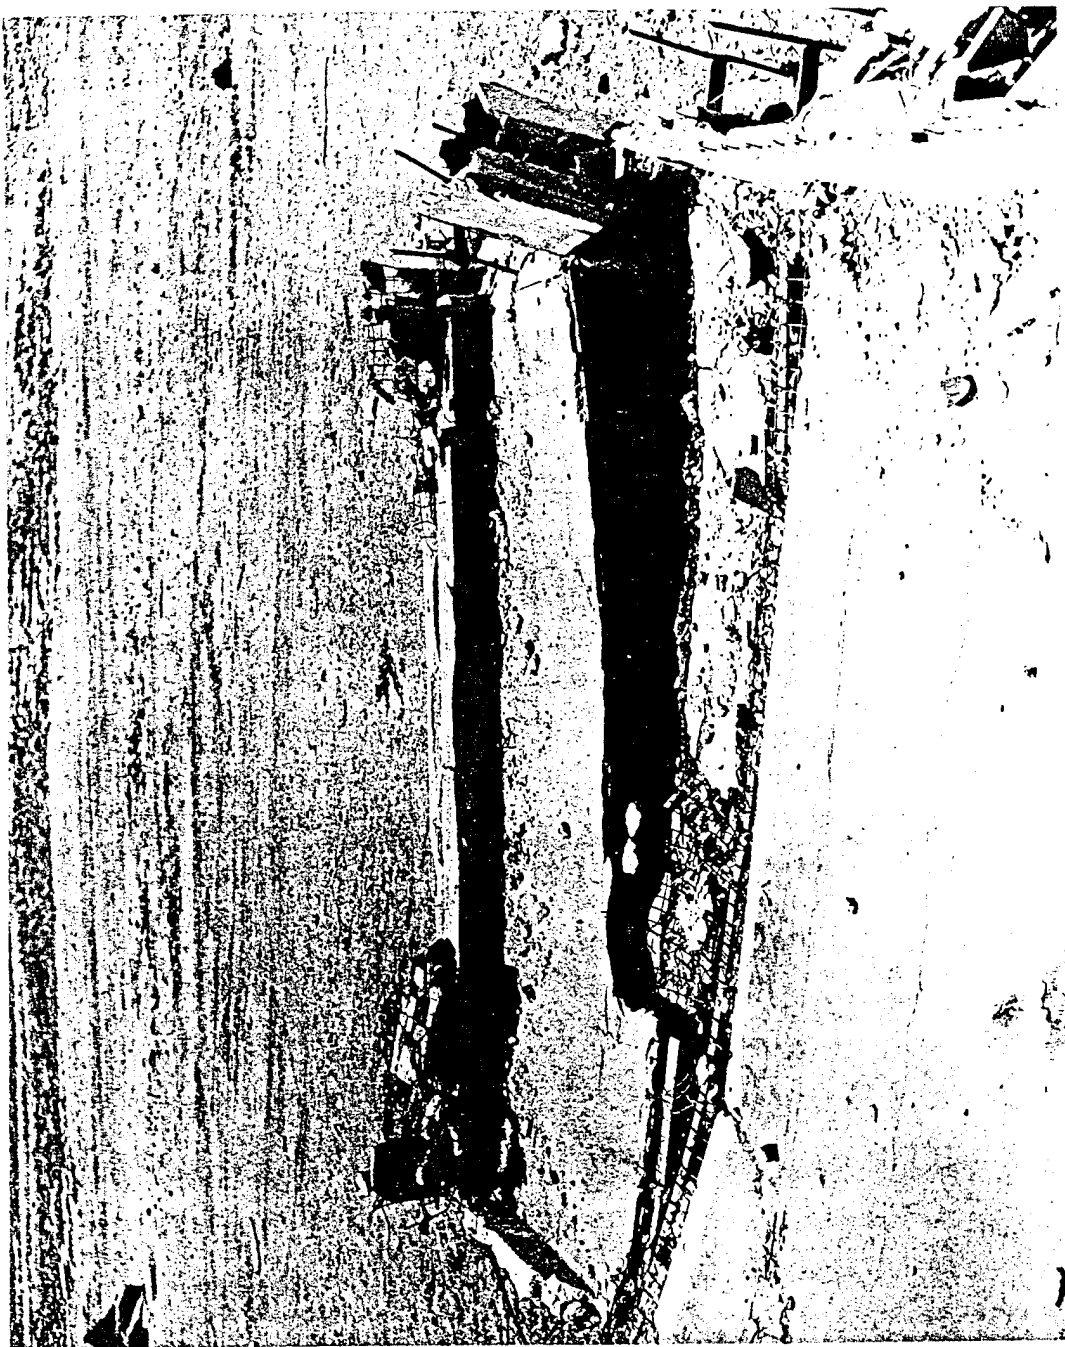
Fig. L.174 Detail View Showing Rupture Within an End-wall Panel, Structure 3.2.3a

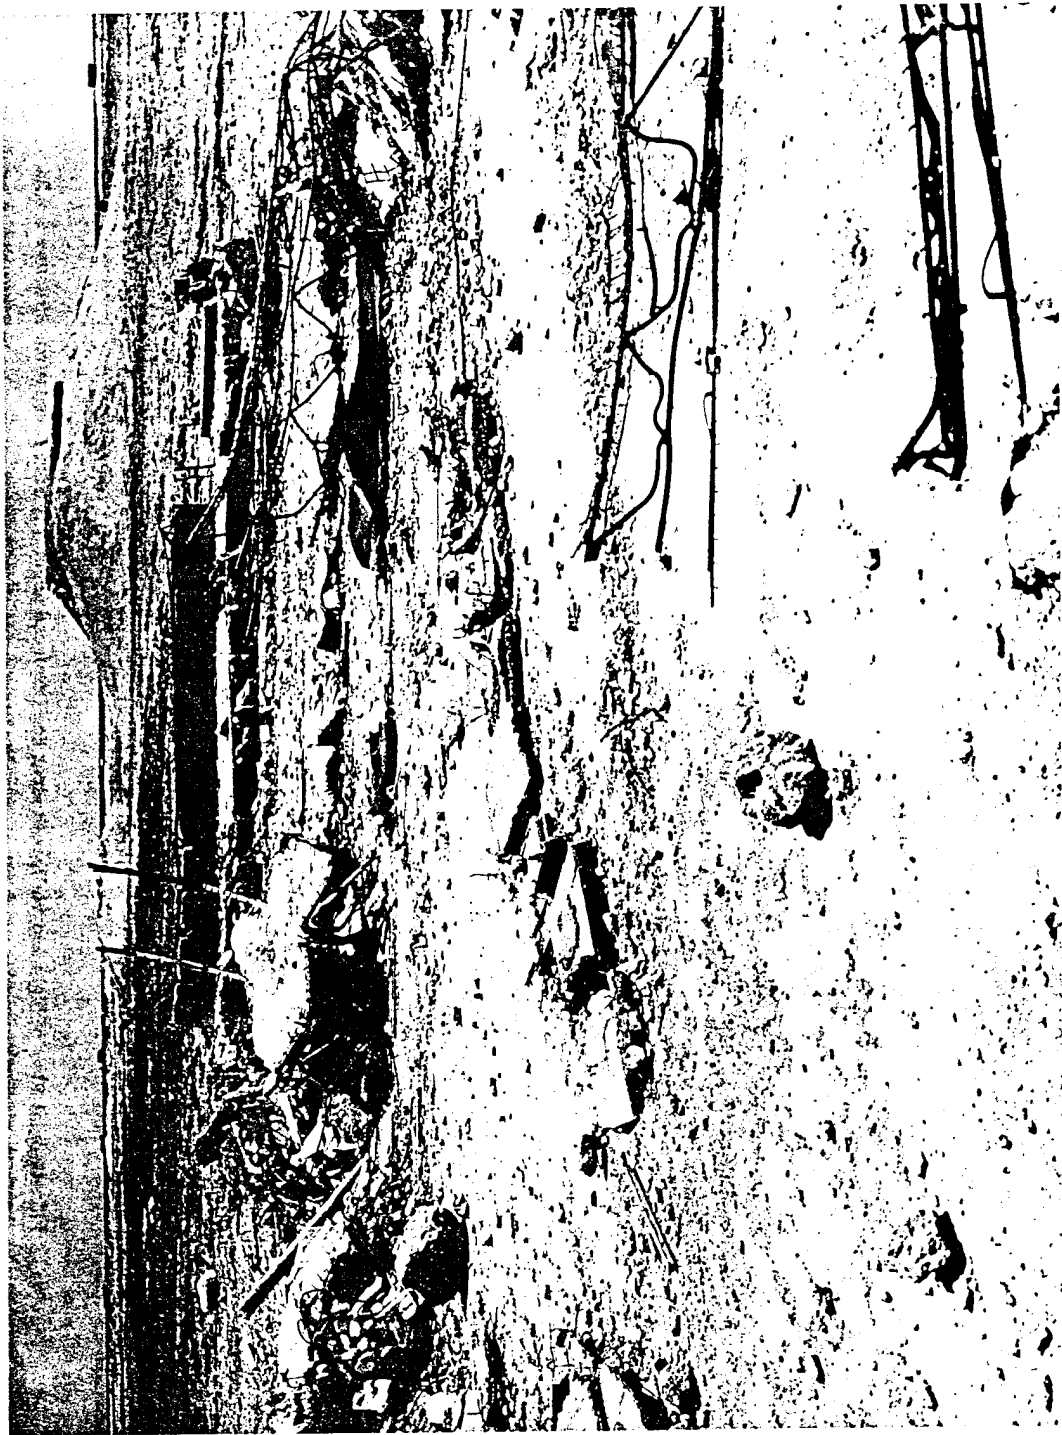
Fig. L.175 General View of Foundation, with Right End Wall in Background, Structure 3.2.3a

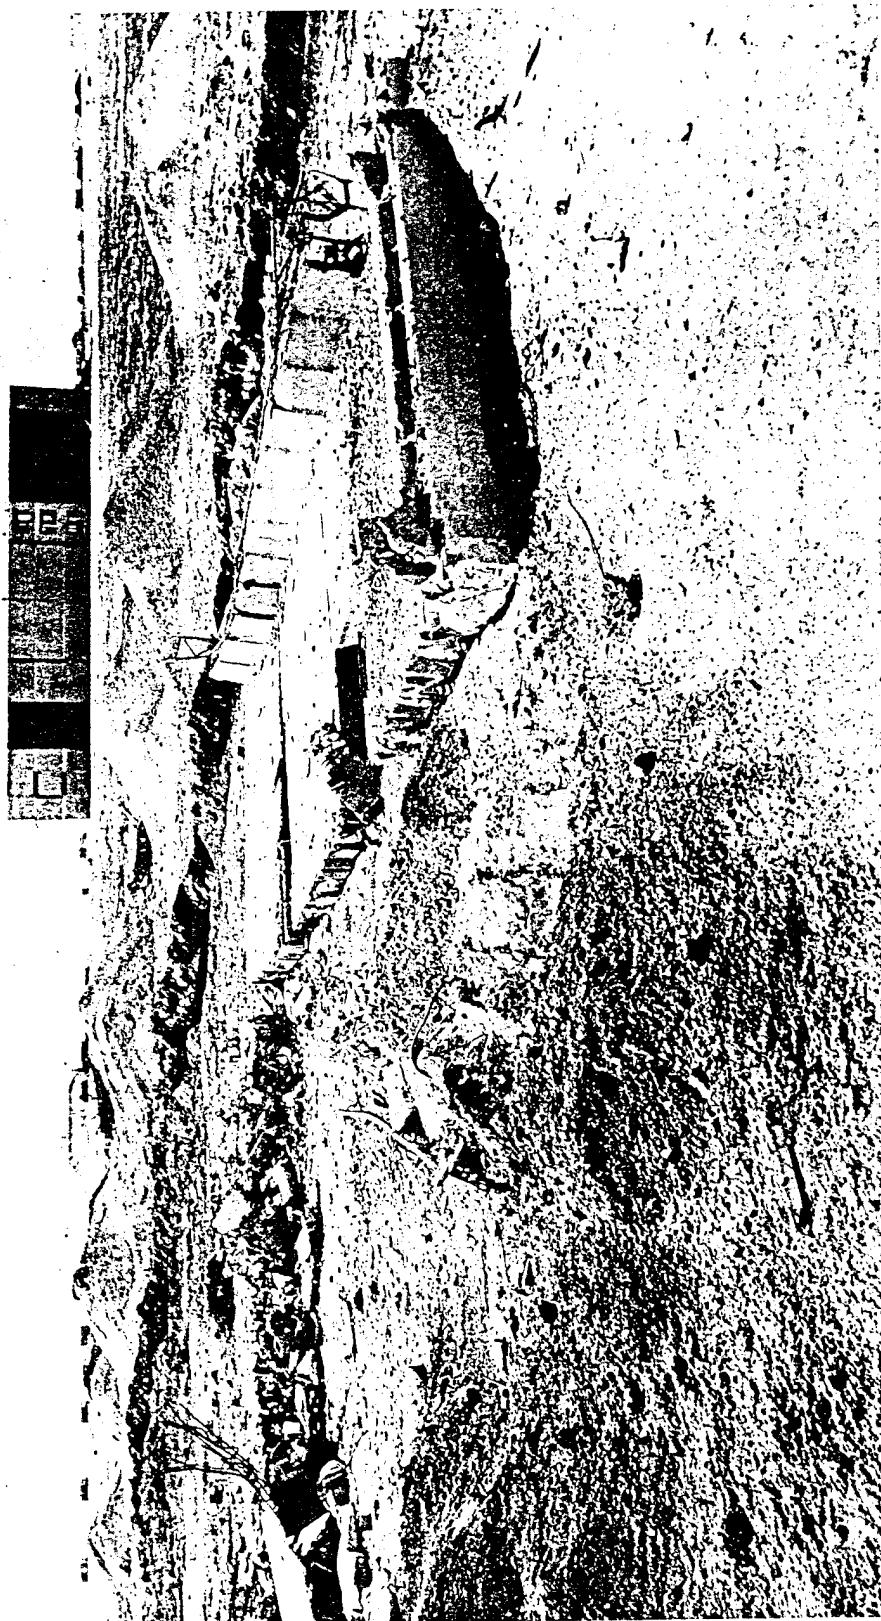
Fig. L.176 General View of Right End Wall, with Front End Displaced about 5 ft from Foundation, Structure 3.2.3a

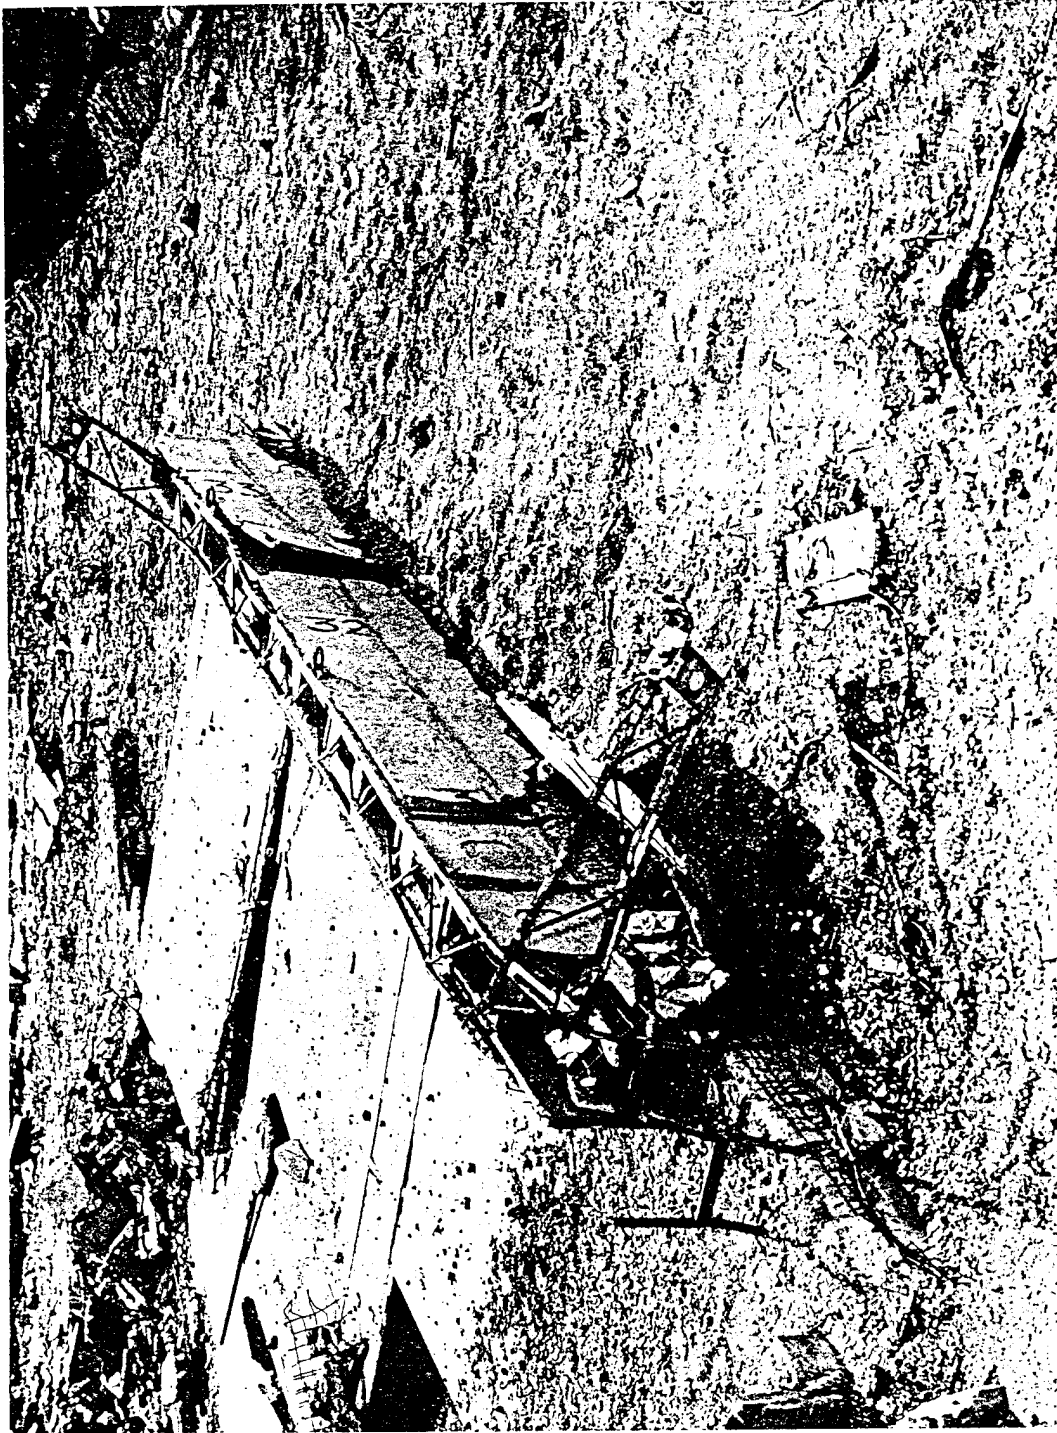
Fig. L.178 Top Edge of Right End Wall, with One Row of Roof Cells Attached, Structure 3.2.3a. Rear panel of end wall split away about 6 in. from rest of wall at lower edge.

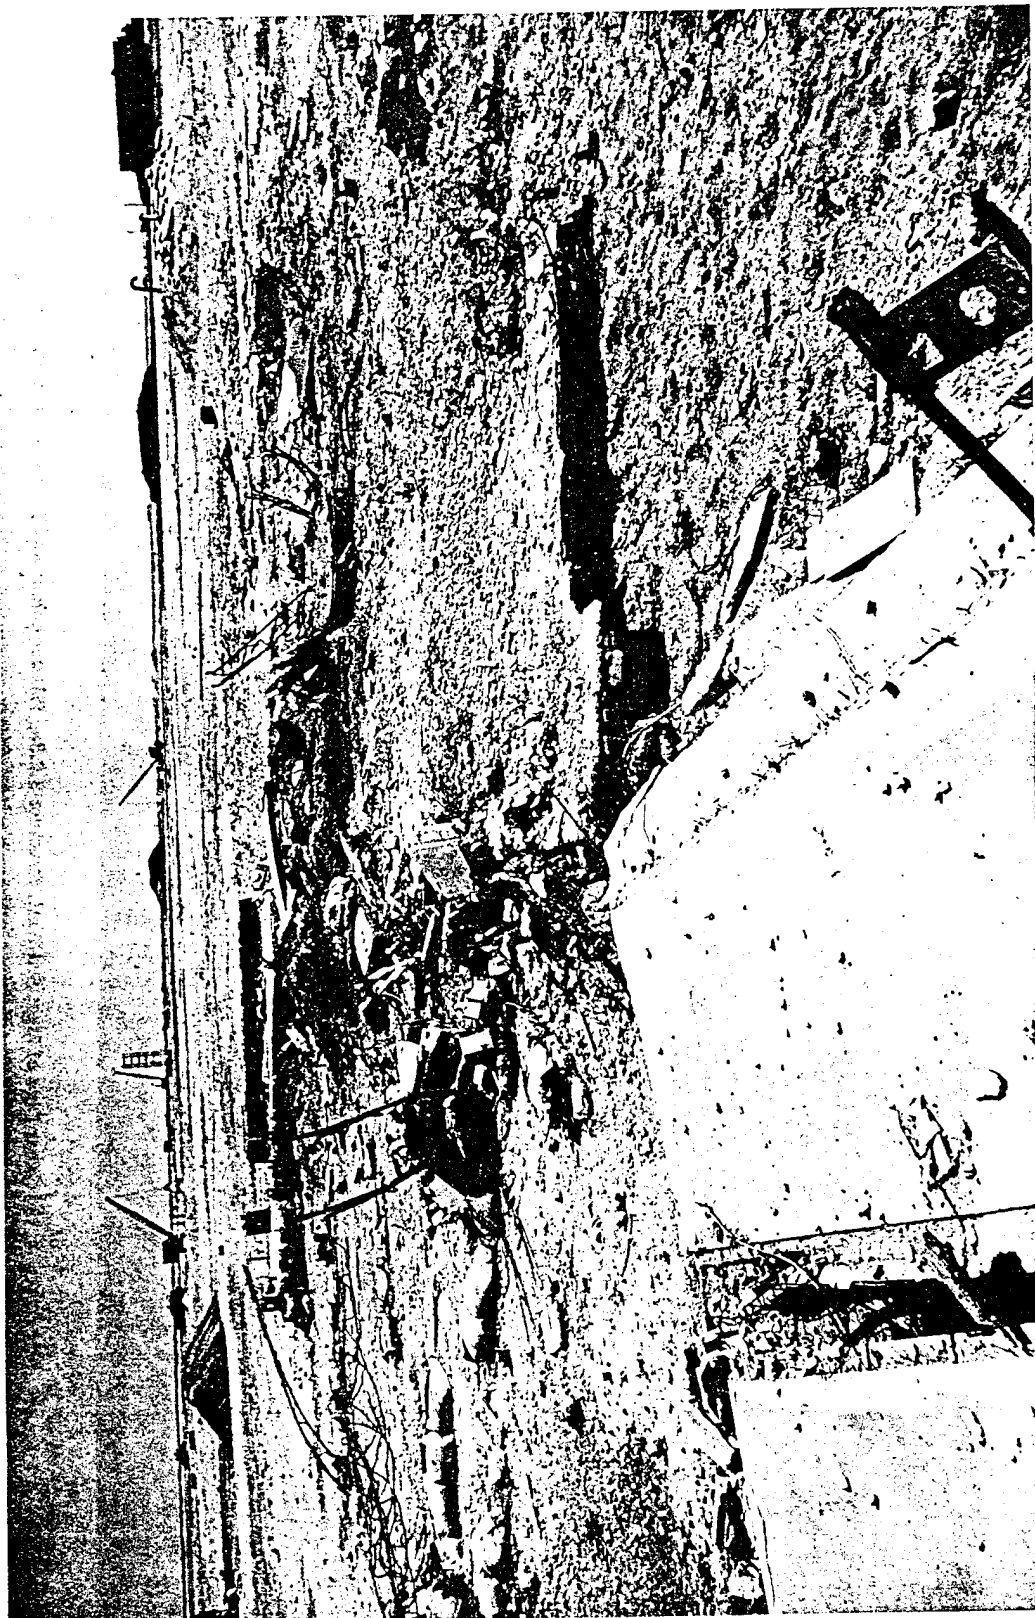
Fig. L.179 Detail View of Split Between Rear Panel and Rest of End Wall, Structure 3.2.3a. Note right edge of rear wall in right center of photograph.

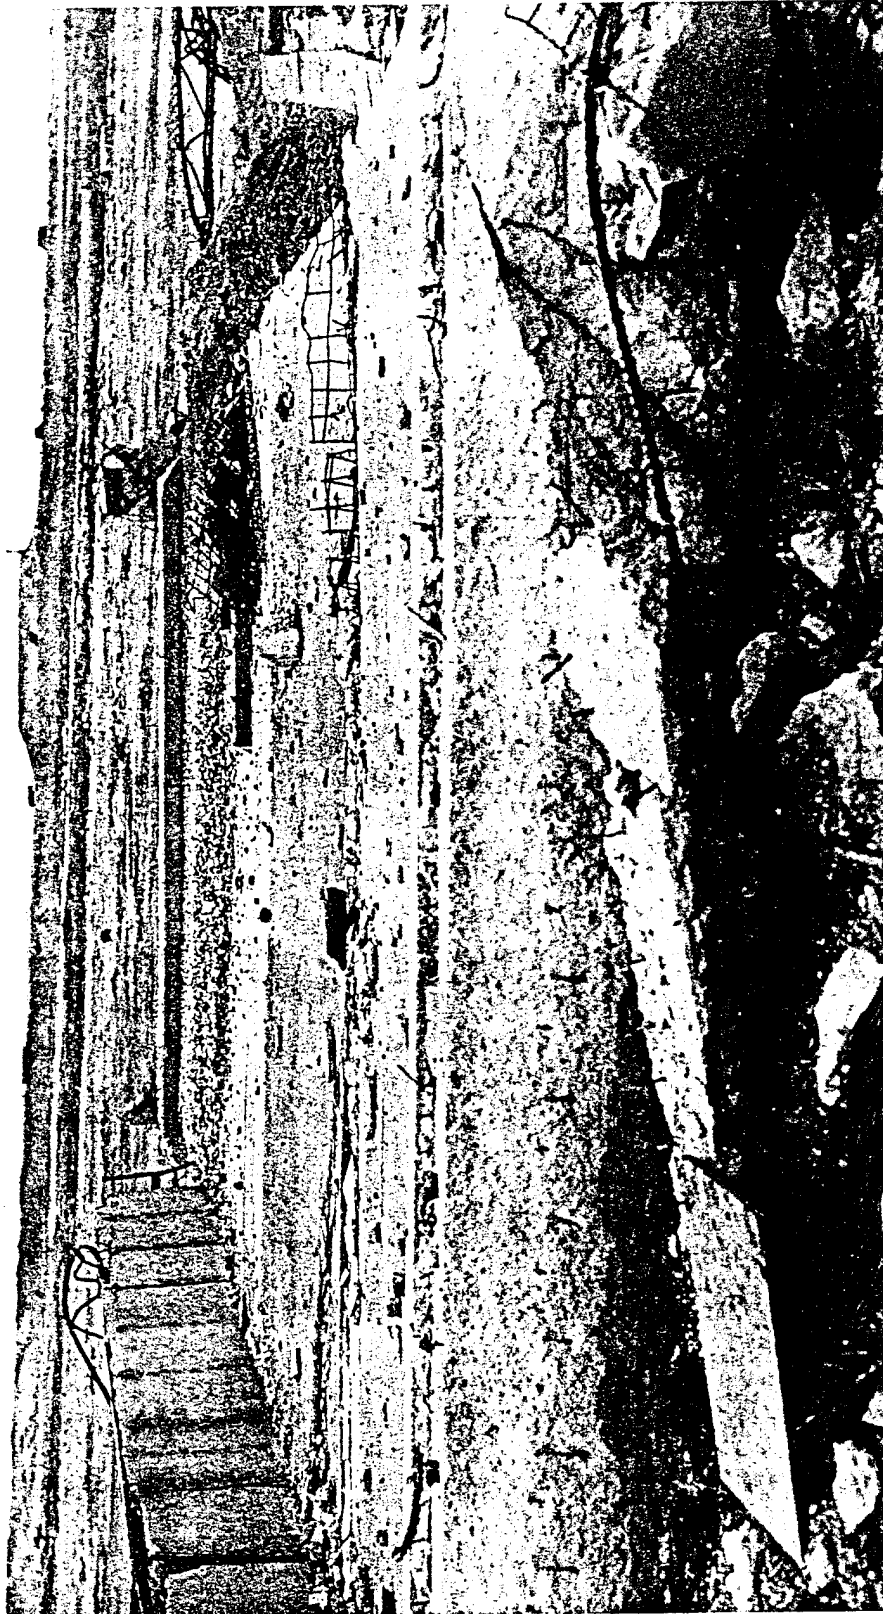
Fig. L.180 Rear Edge of Right End Wall, Structure 3.2.3a. Plaster corner was heavily damaged.

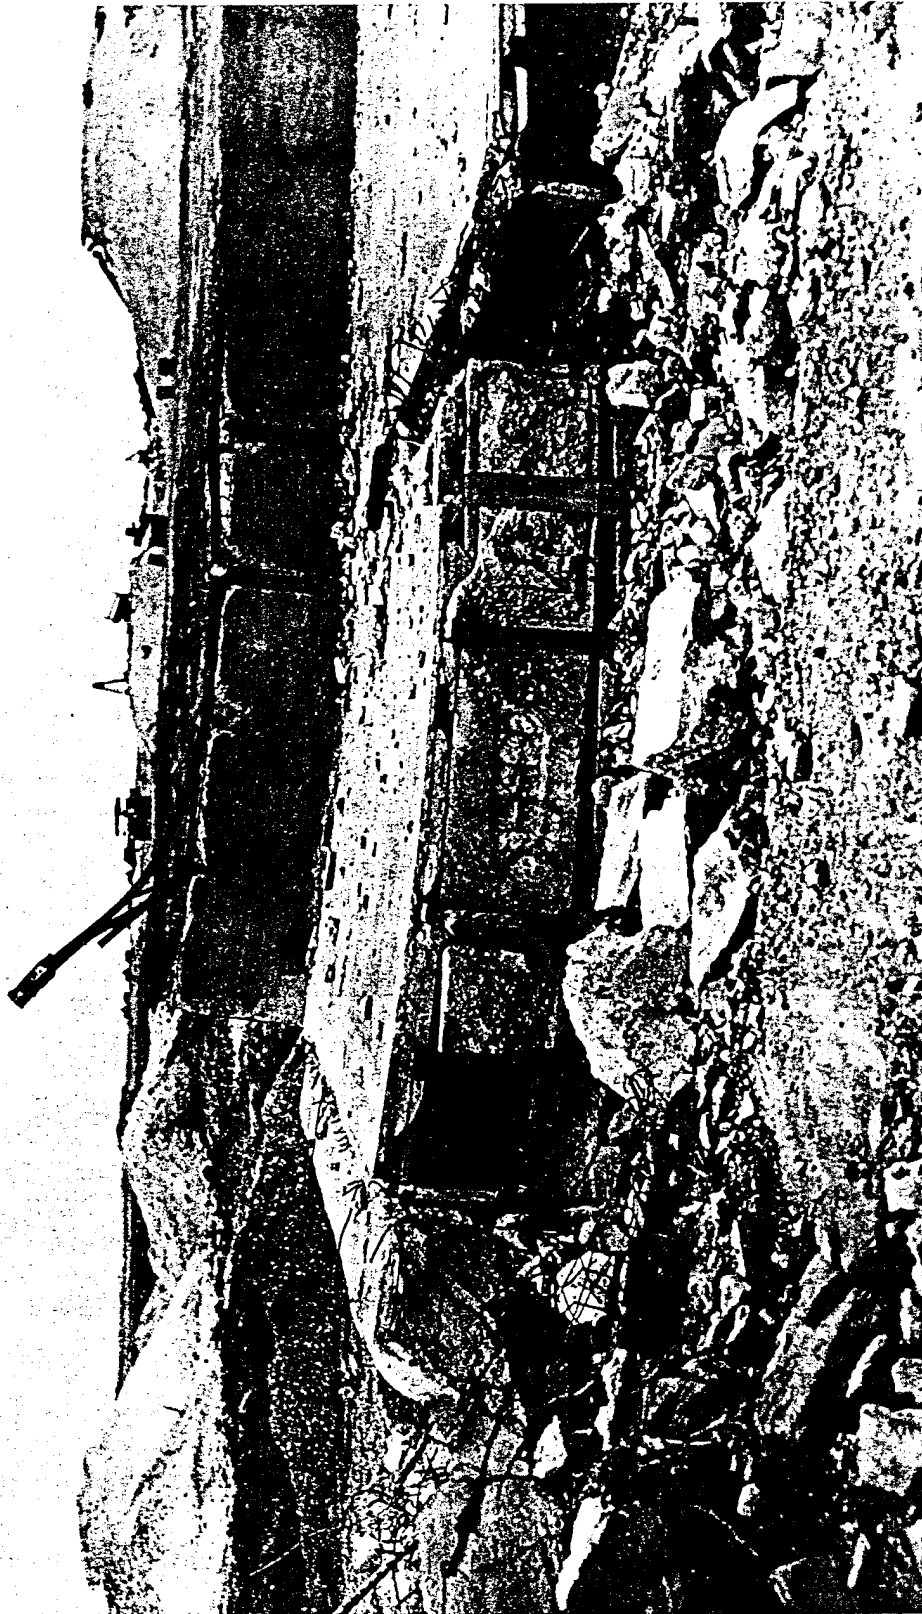
Fig. L.182 Base of Rear Panel of Right End Wall, Structure 3.2.3a. Trusses broke loose from channels by rupturing through weld.

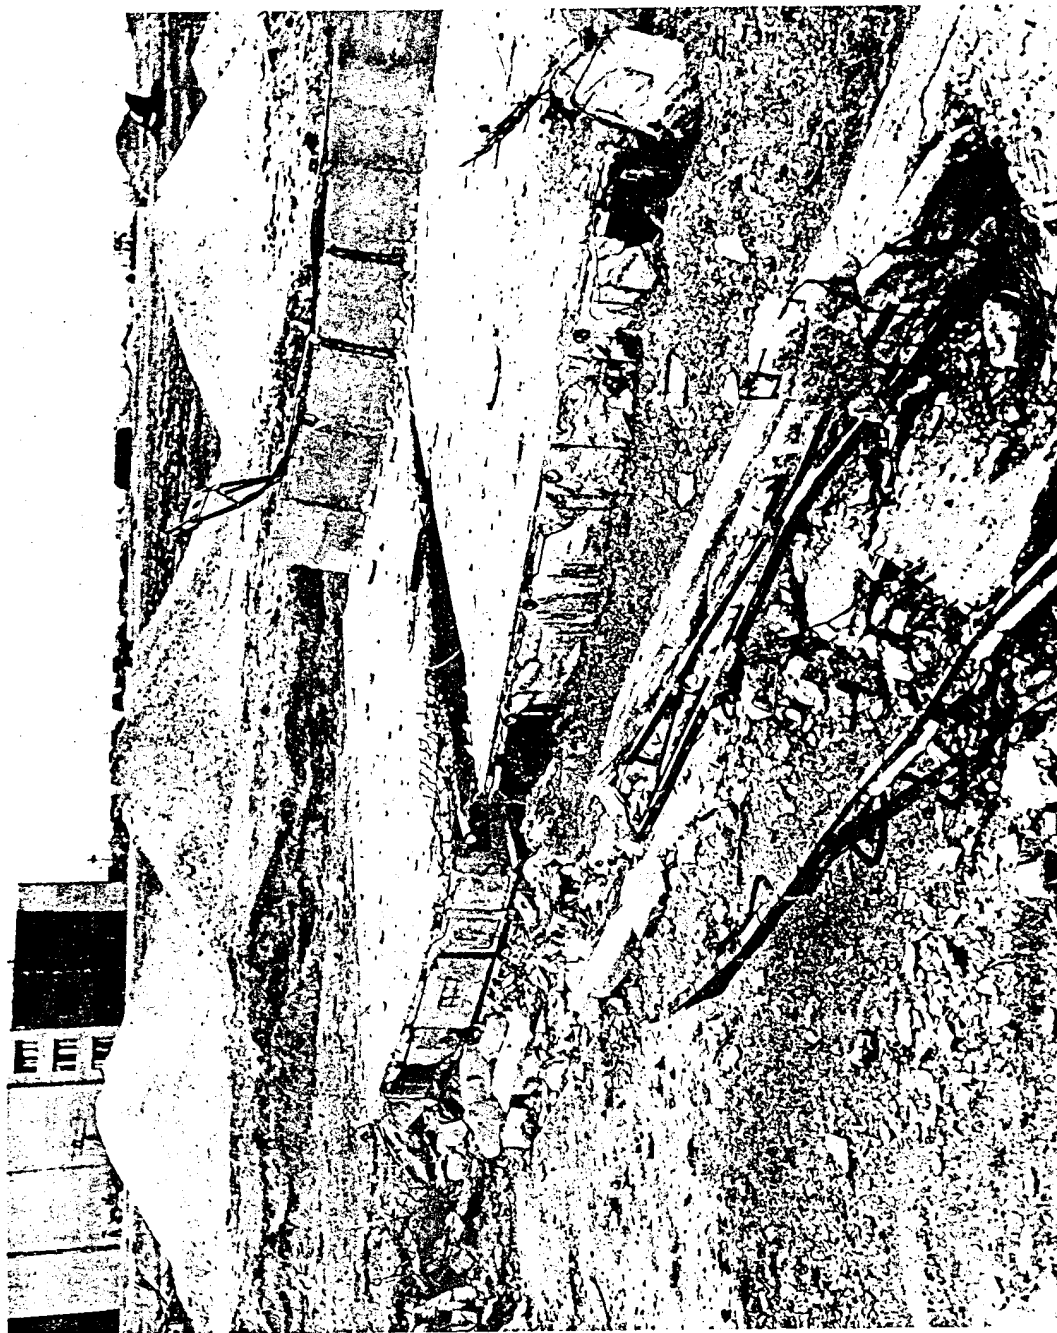
Fig. L.183 Base of Right End Wall, Structure 3.2.3a. Trusses in center broke loose from anchorage by shearing out the base metal of the anchor channel. Remnants of front wall can be seen in foreground.

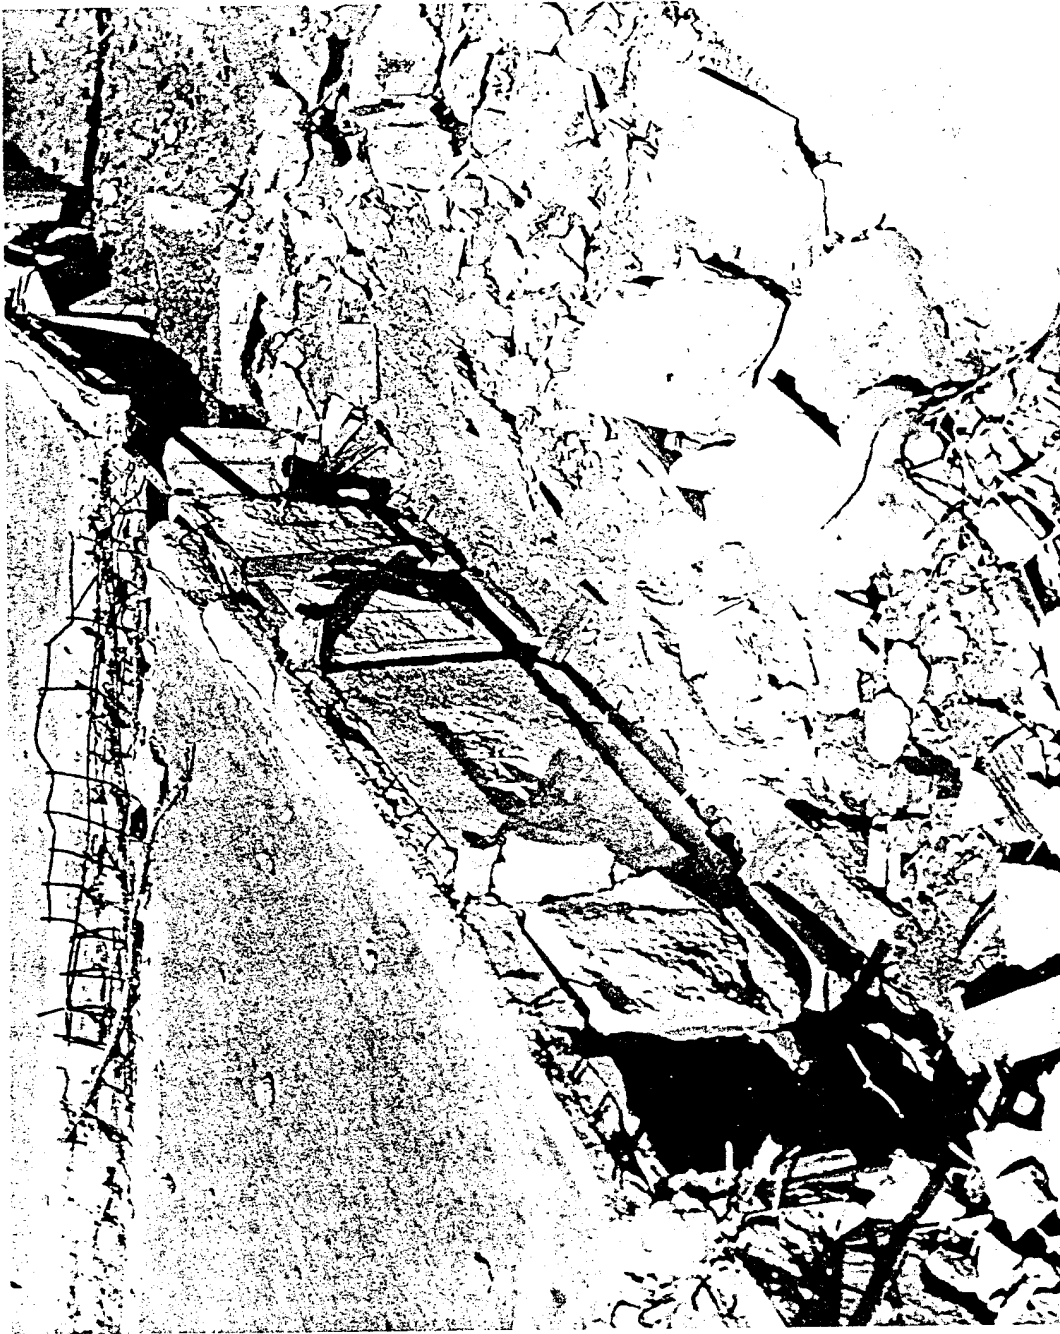
Fig. L.184 Detail View of Base of Rear Panel in Right End Wall, Structure 3.2.3a

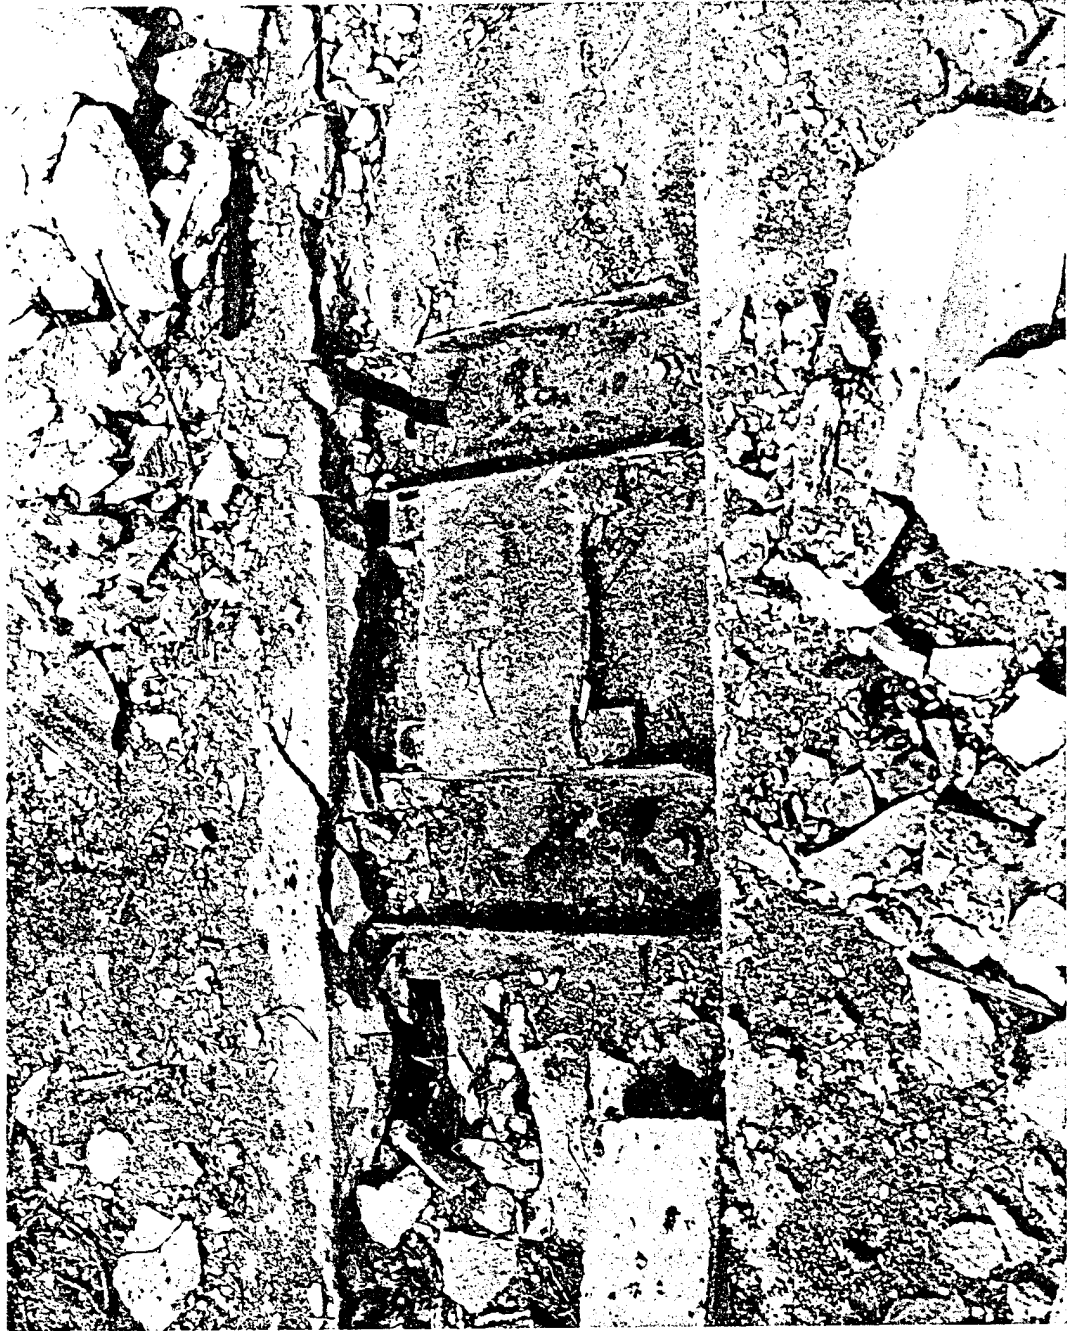
Fig. L.185 Channels That Were Welded to Trusses of Preceding Photograph Still Anchored to Foundation,
Structure 3.2.3a

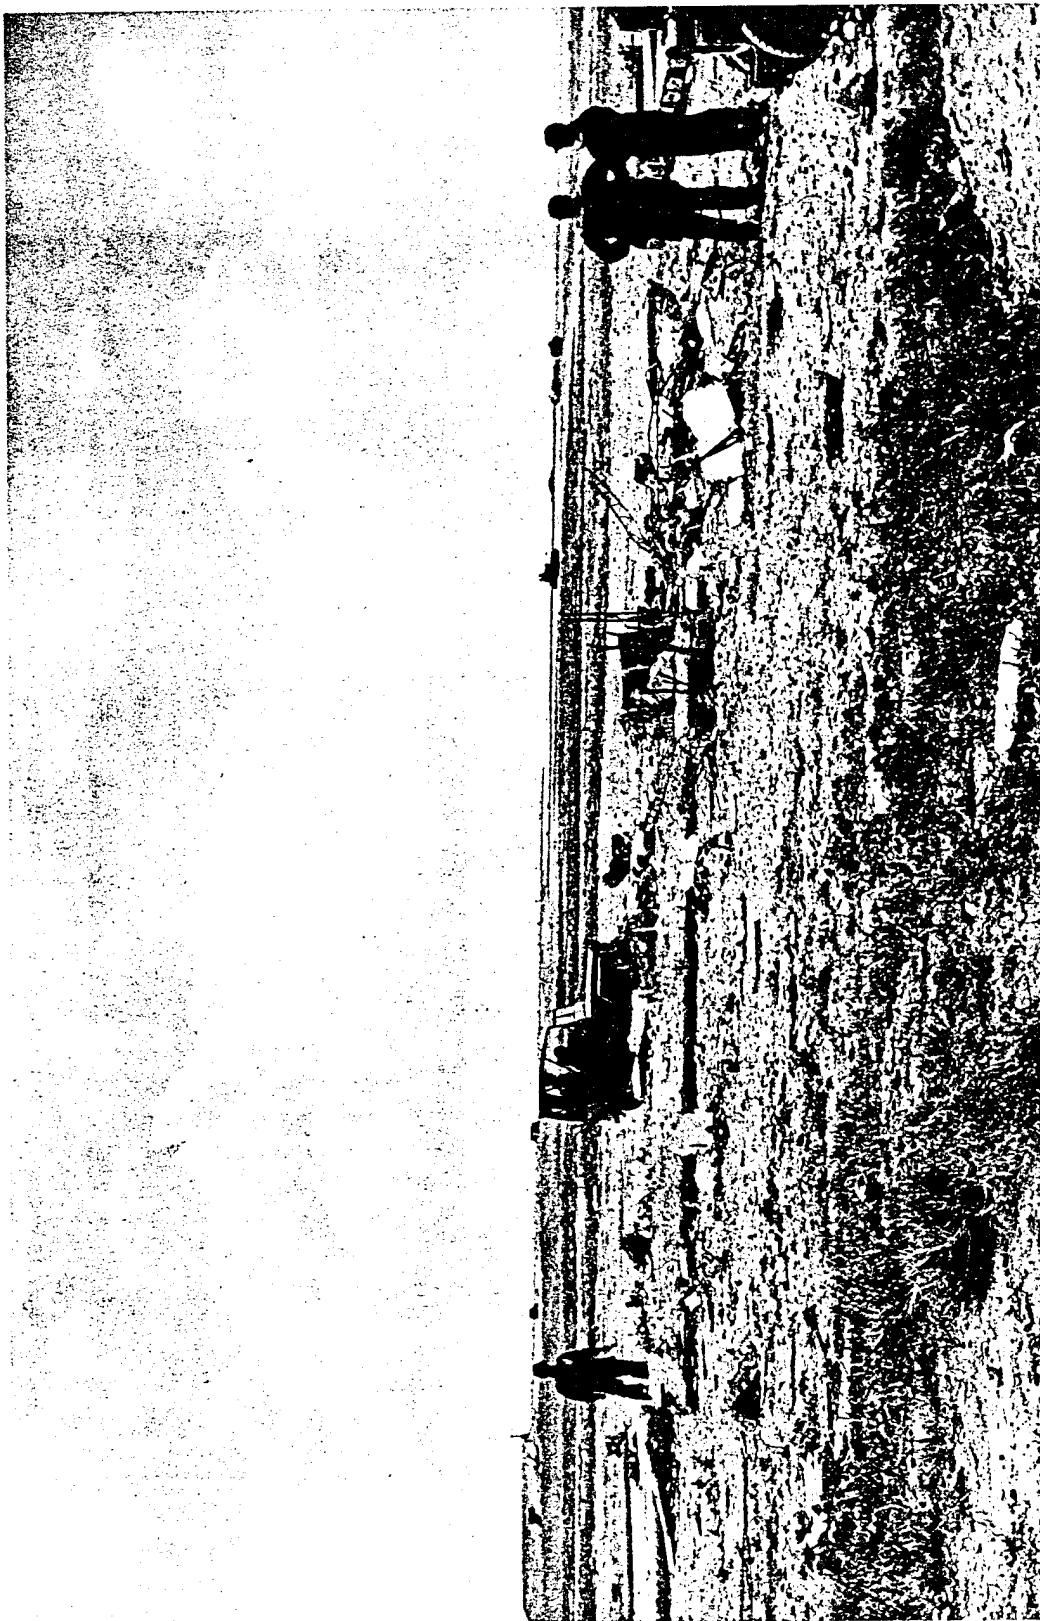
Fig. L.186 General View of Rear Wall, Taken from Rear, Structure 3.2.3a. Top edge of wall can be seen in left center of photograph.

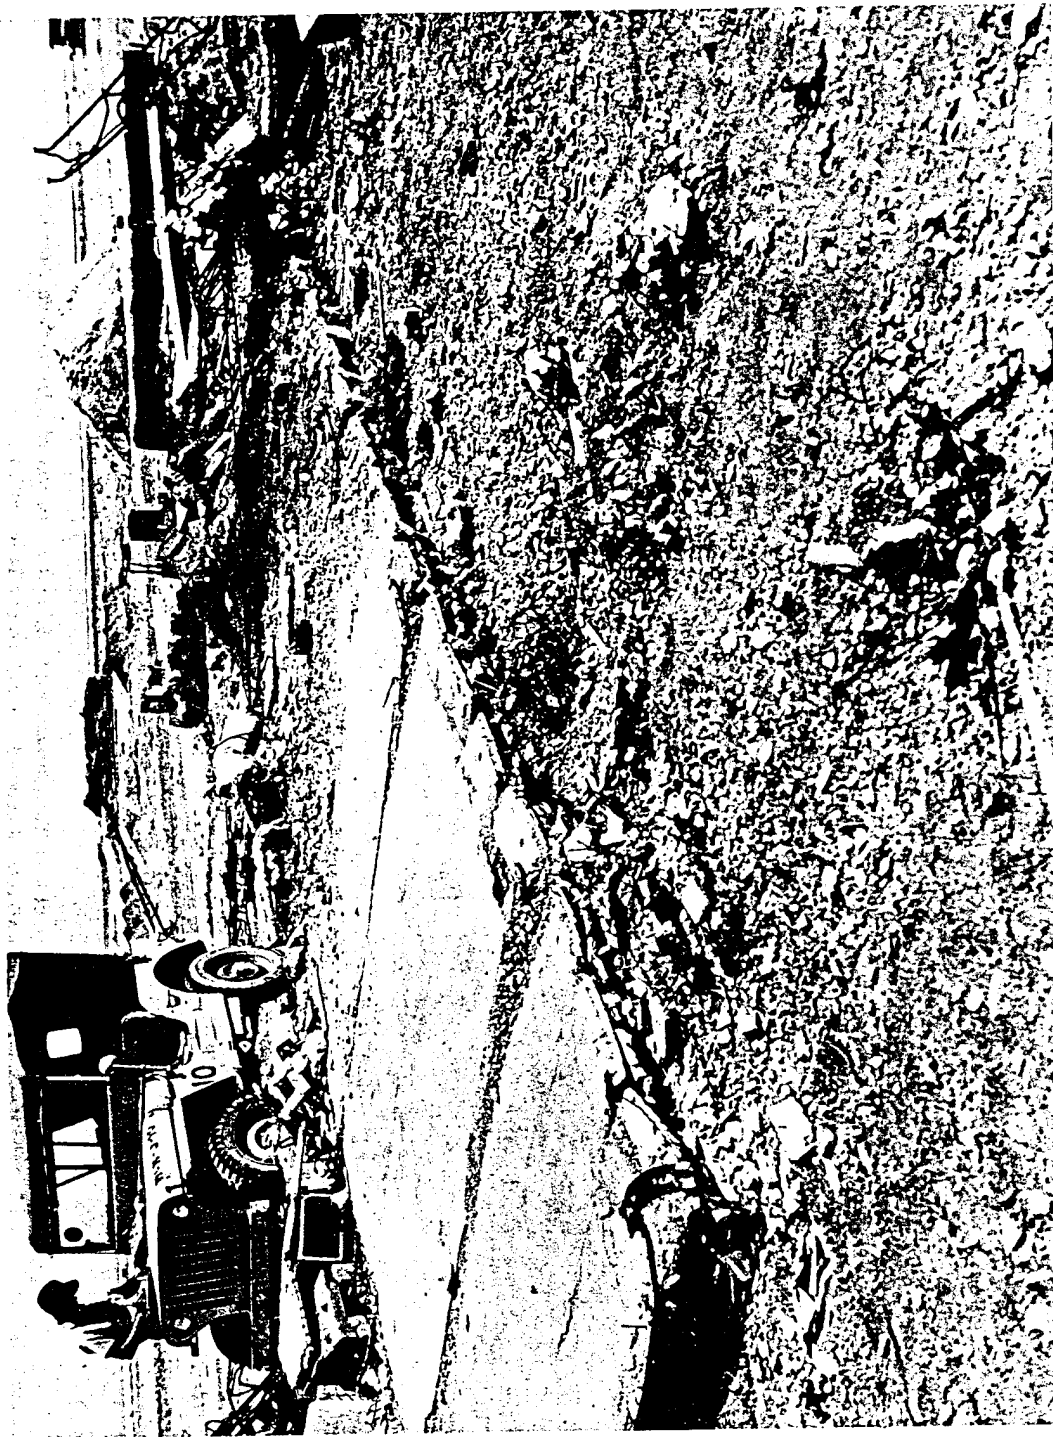
Fig. L.187 Rear Wall, Structure 3.2.3a. Top edge line can be clearly seen. Note the very slight damage within panels.

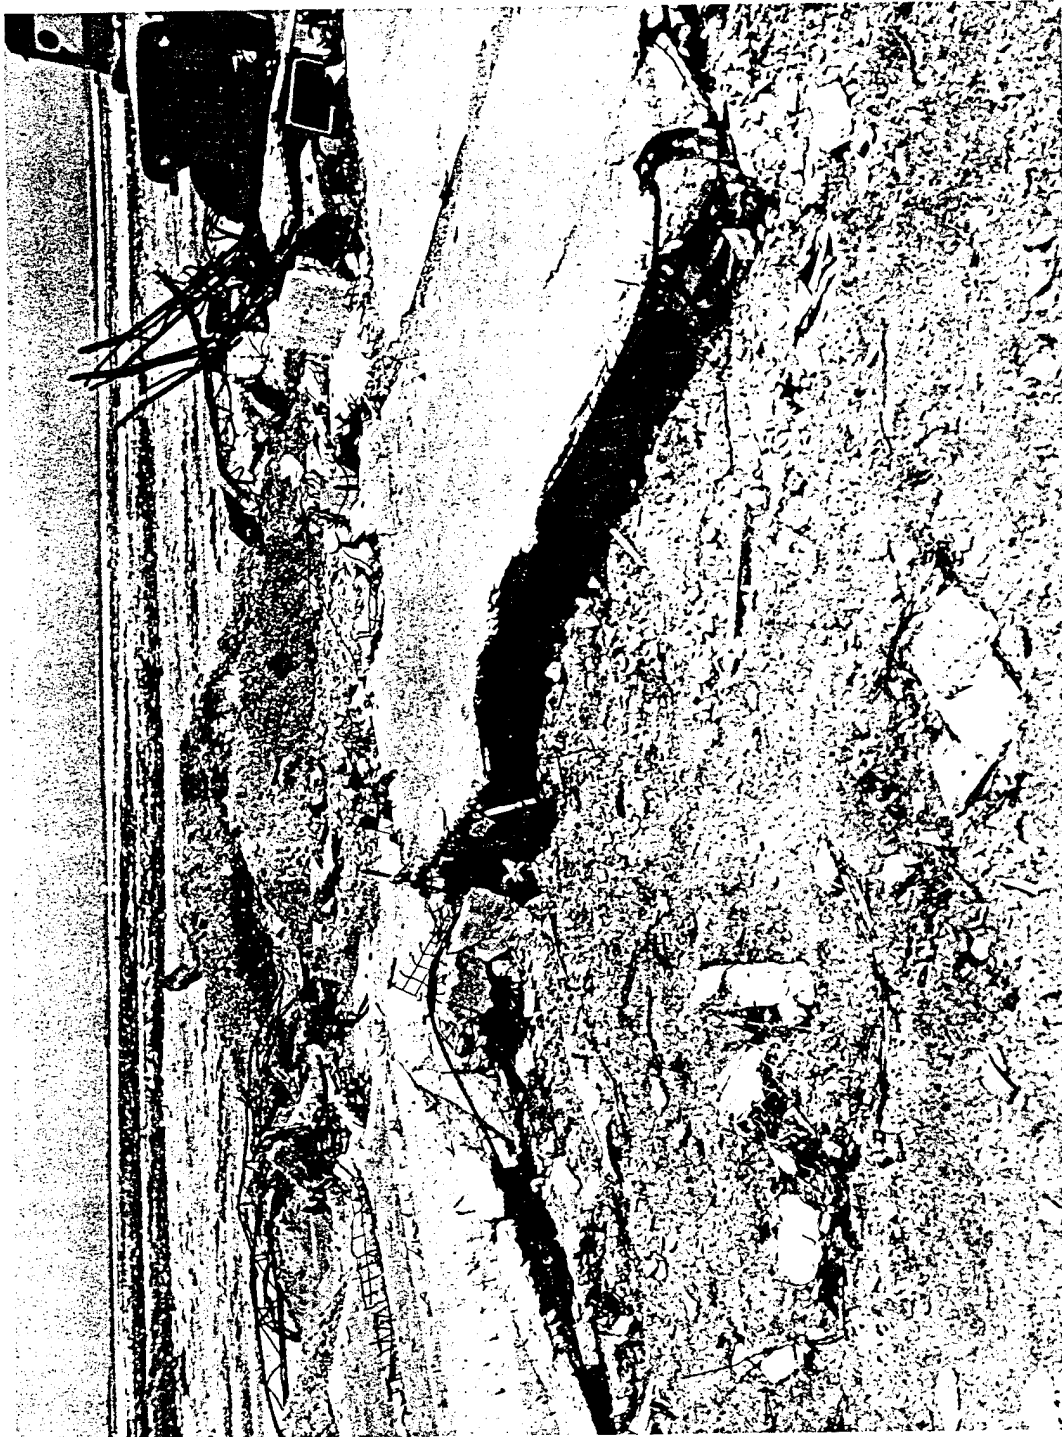
Fig. 'L.188 Detail View of Right Edge of Rear Wall, Structure 3.2.3a. Part of one row of cells was torn loose when right end wall rotated outward, taking corner pillar with it.
